Nine Springs Valley Interceptor – Mineral Point Extension: Pipe Investigation Update

Commission Meeting March 13, 2025

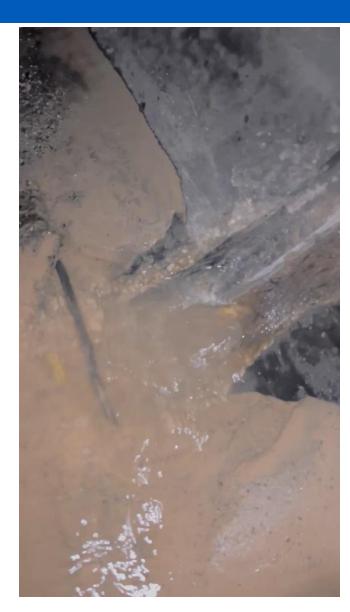
Video: Offset Joint during repair

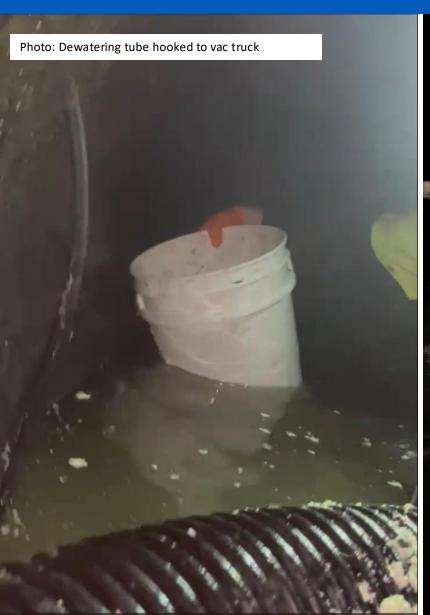
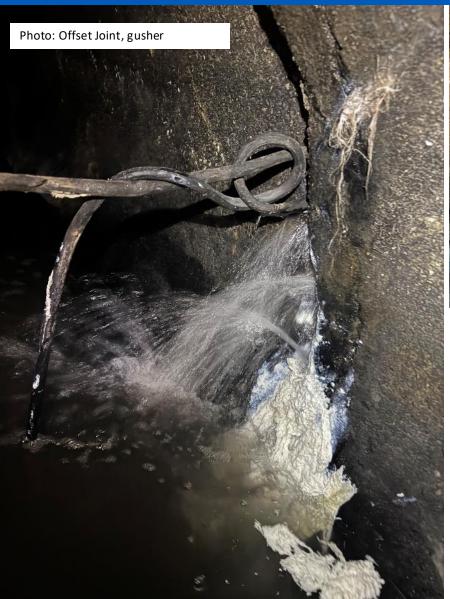
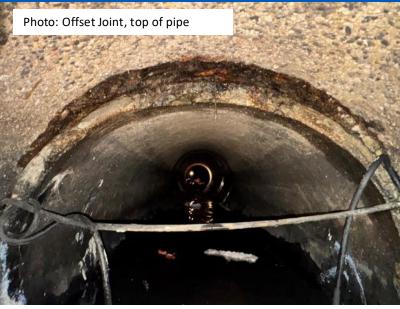
Photos – O/S Joint 300-ft During Repair

- I/I rate
- Water level

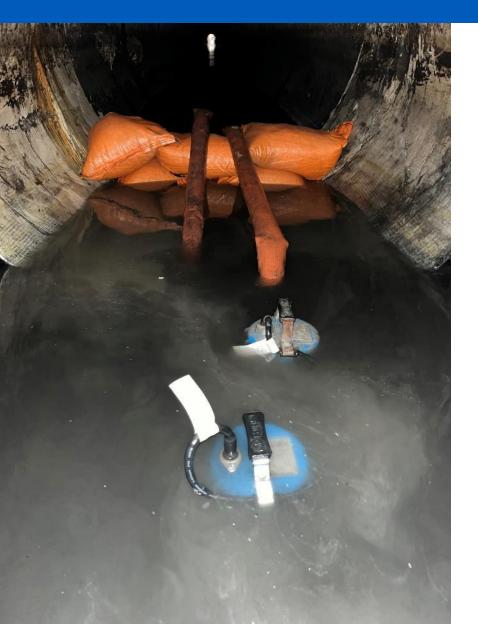
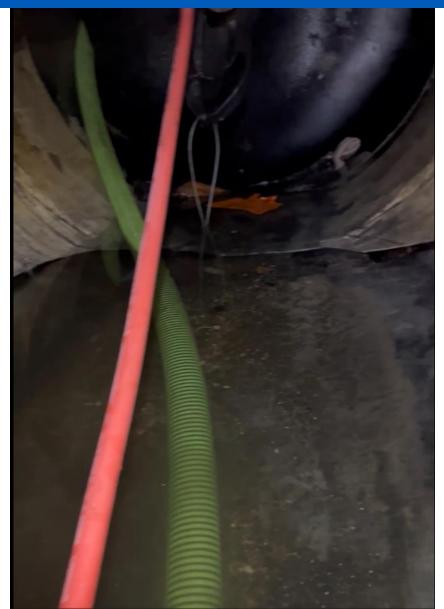
Photos – O/S Joint 284-ft – During Repair

- Decreased water level
- No water movement

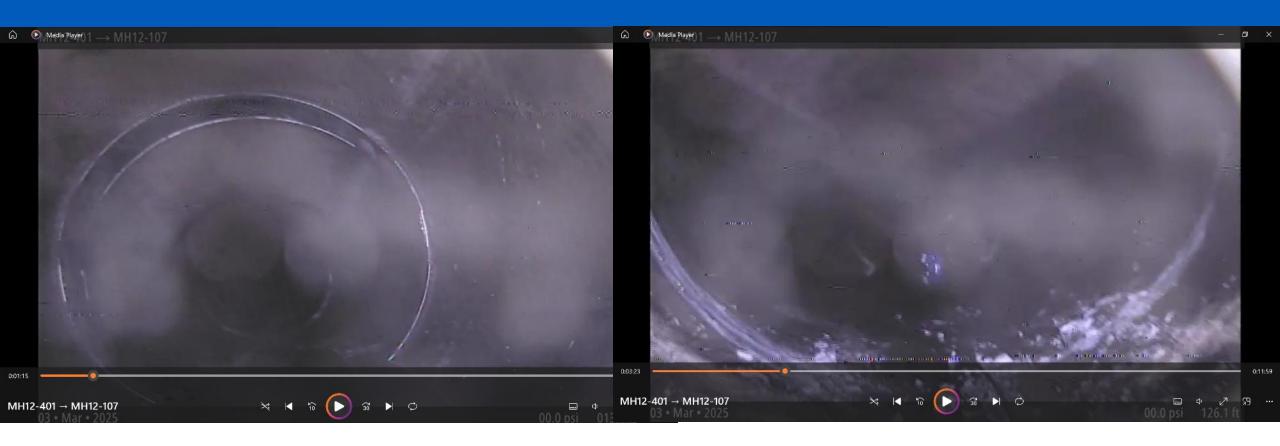
Repair Photos – Other joints after repair

- Water level
- See bottom pipe
