BADGER MILL CREEK HYDROLOGIC ASSESSMENT

Date	04/24/2023
To / Contact info	Kathy Lake, PE, ENV-SP
From / Contact info	Nick Hayden, Steve Gaffield, and Joe Pallardy
Regarding	Streamflow & habitat observations during experimental effluent shutdown

Executive Summary

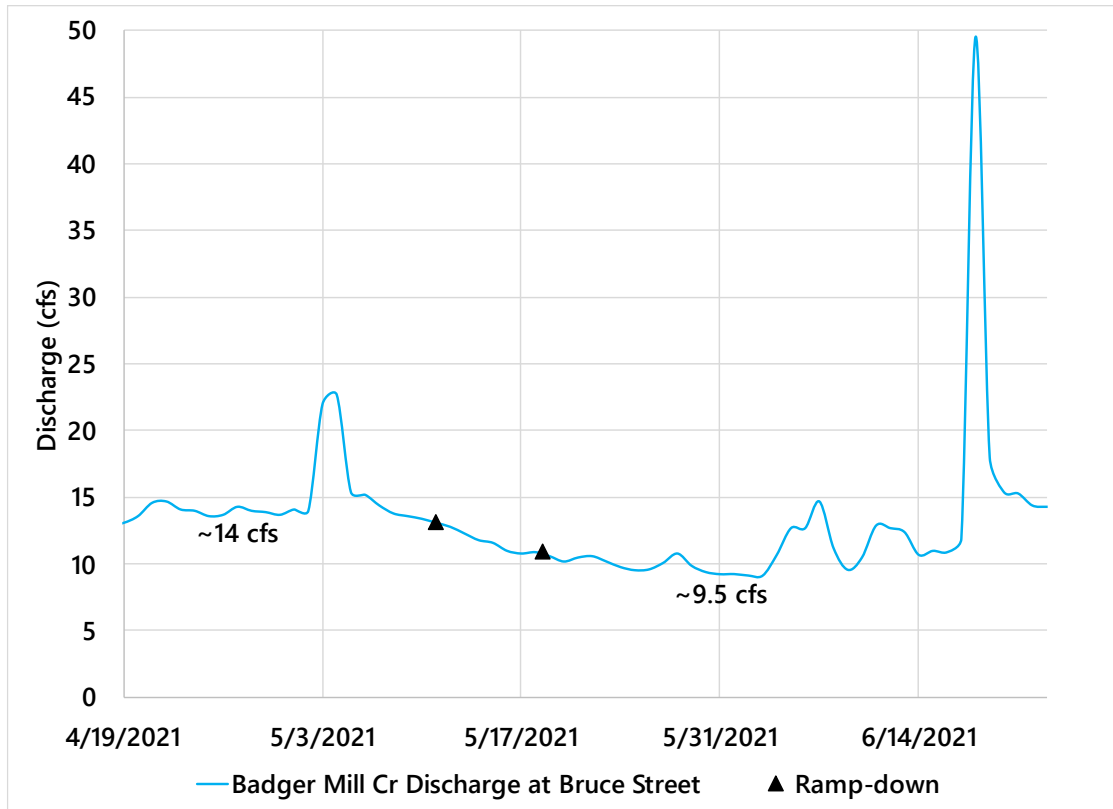
gage on Badger Mill Creek at Bruce Street during a previous shutdown in May and June 2021. As shown by the gage hydrograph (Figure 1) during that time period, the baseflow prior to the event was close to 14 cubic feet per second (cfs). The effluent discharge was reduced from May 11th to May 18th, with an immediate impact of dropping flows in Badger Mill Creek. The flow dropped further and reached an equilibrium within seven days of the effluent being completely off, with a new baseflow hovering around 9.5 cfs (ignoring short-term impacts from rainfall). This event provided confidence that a similar seven-day gradual reduction to zero followed by a seven-day equilibration period would be ample time for the creek’s baseflow to adjust and represent a non-effluent discharge condition.

Figure 1. Baseflow Response to May 2021 Effluent Shut-off.

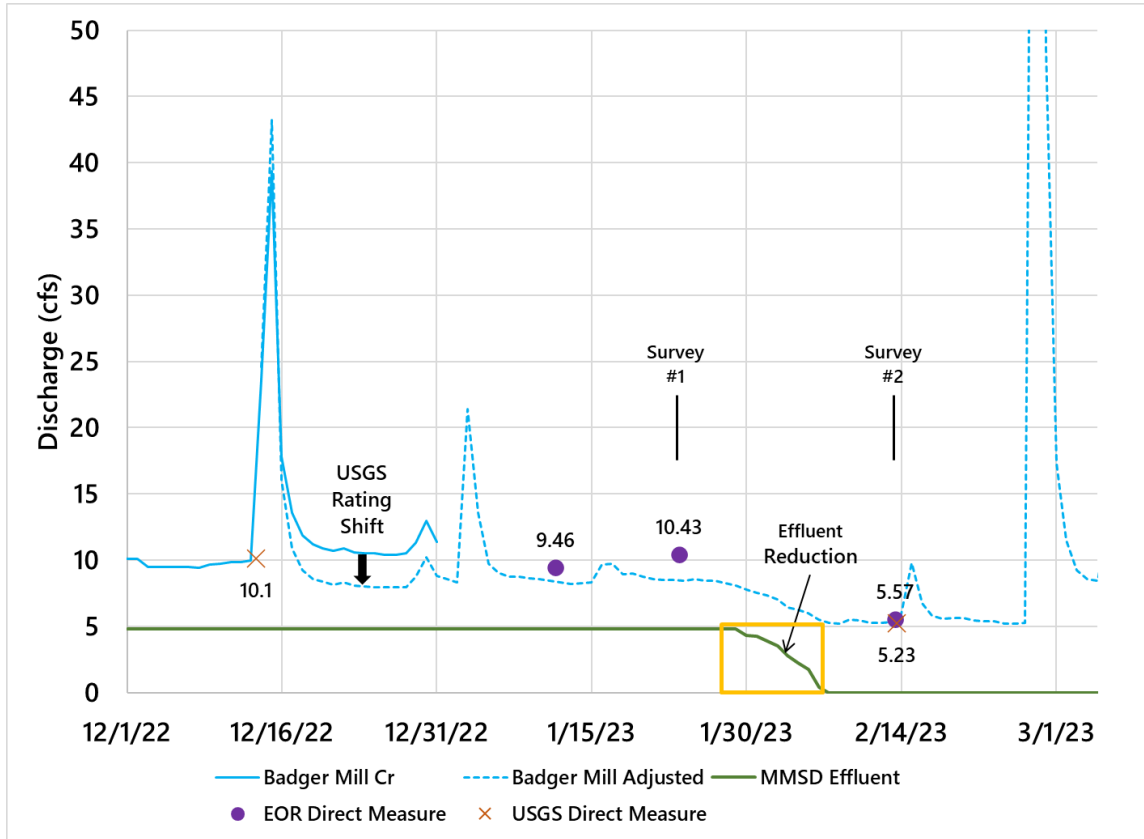
Figure 2 shows discharge data from the continuous USGS gage station on Badger Mill Creek at Bruce Street, MMSD effluent discharge, and direct discharge measurements made by EOR and USGS. Note that the USGS applied a uniform shift to their site rating curve after their direct discharge measurement on February 13th, which effectively lowered their previous baseflow discharge estimate by 2.5 cfs following the December 15th runoff event’s recession. The USGS applies rating curve shifts when their direct discharge measurement does not match their rating curve for a given stage, and this is typically attributed to changes in channel geometry (sediment deposition or scour) following a high flow event. This complicates the use of their data for the period between December 15th and February 13th when they did not have a direct measurement. Prior to the rating shift, EOR’s direct measurement on January 23rd (10.43 cfs) was within five percent of the USGS’ provisional discharge value at the same time (11.0 cfs), which is relatively good agreement for a natural channel measurement from different operators and equipment. After the shift, EOR’s value is 1.9 cfs higher than the revised USGS provisional value. On February 13th, when both EOR and USGS took a measurement on Badger Mill Creek, EOR’s value (5.57 cfs) was within seven percent of the USGS value (5.23 cfs). Both EOR and USGS also took a discharge measurement at the STH 69 Sugar River gage on that day, and those measurements were within three percent of each other. Based on these relatively tight concurrent measurements, the following analysis and discussion of discharge data during the effluent reduction period will focus more on the spatially distributed EOR measurements than the shifted USGS Bruce Street gage values.

Figure 2. Badger Mill Creek at Bruce Street and Effluent Hydrographs, December 2022 through Feb 2023.
