Memorandum

To	Eric Hjellen, Madison Metropolitan Sewerage District Lisa Coleman, Madison Metropolitan Sewerage District	Page	1
CC	Tim Barbeau, raSmith; Chris Tippery, raSmith; Rick Eilertson, AECOM		
Subject	Private Well Review for the Lower Badger Mill Creek Interceptor Project, Phase 6, Town of Verona, Wisconsin – AECOM Project No. 60694467		
From	Leo Linnemanstons, PG, AECOM		
Date	June 4, 2024 (updated 7/3/2024) ¹

AECOM is presenting this technical memorandum of potential concerns or impacts for nearby private wells that may be affected by construction activities along the Phase 6 Segment of the Lower Badger Mill Creek Interceptor (LBMCI) project.

Phase 6
Lower Badger Mill Creek
Interceptor (LBMCI) Project
Verona, Wisconsin

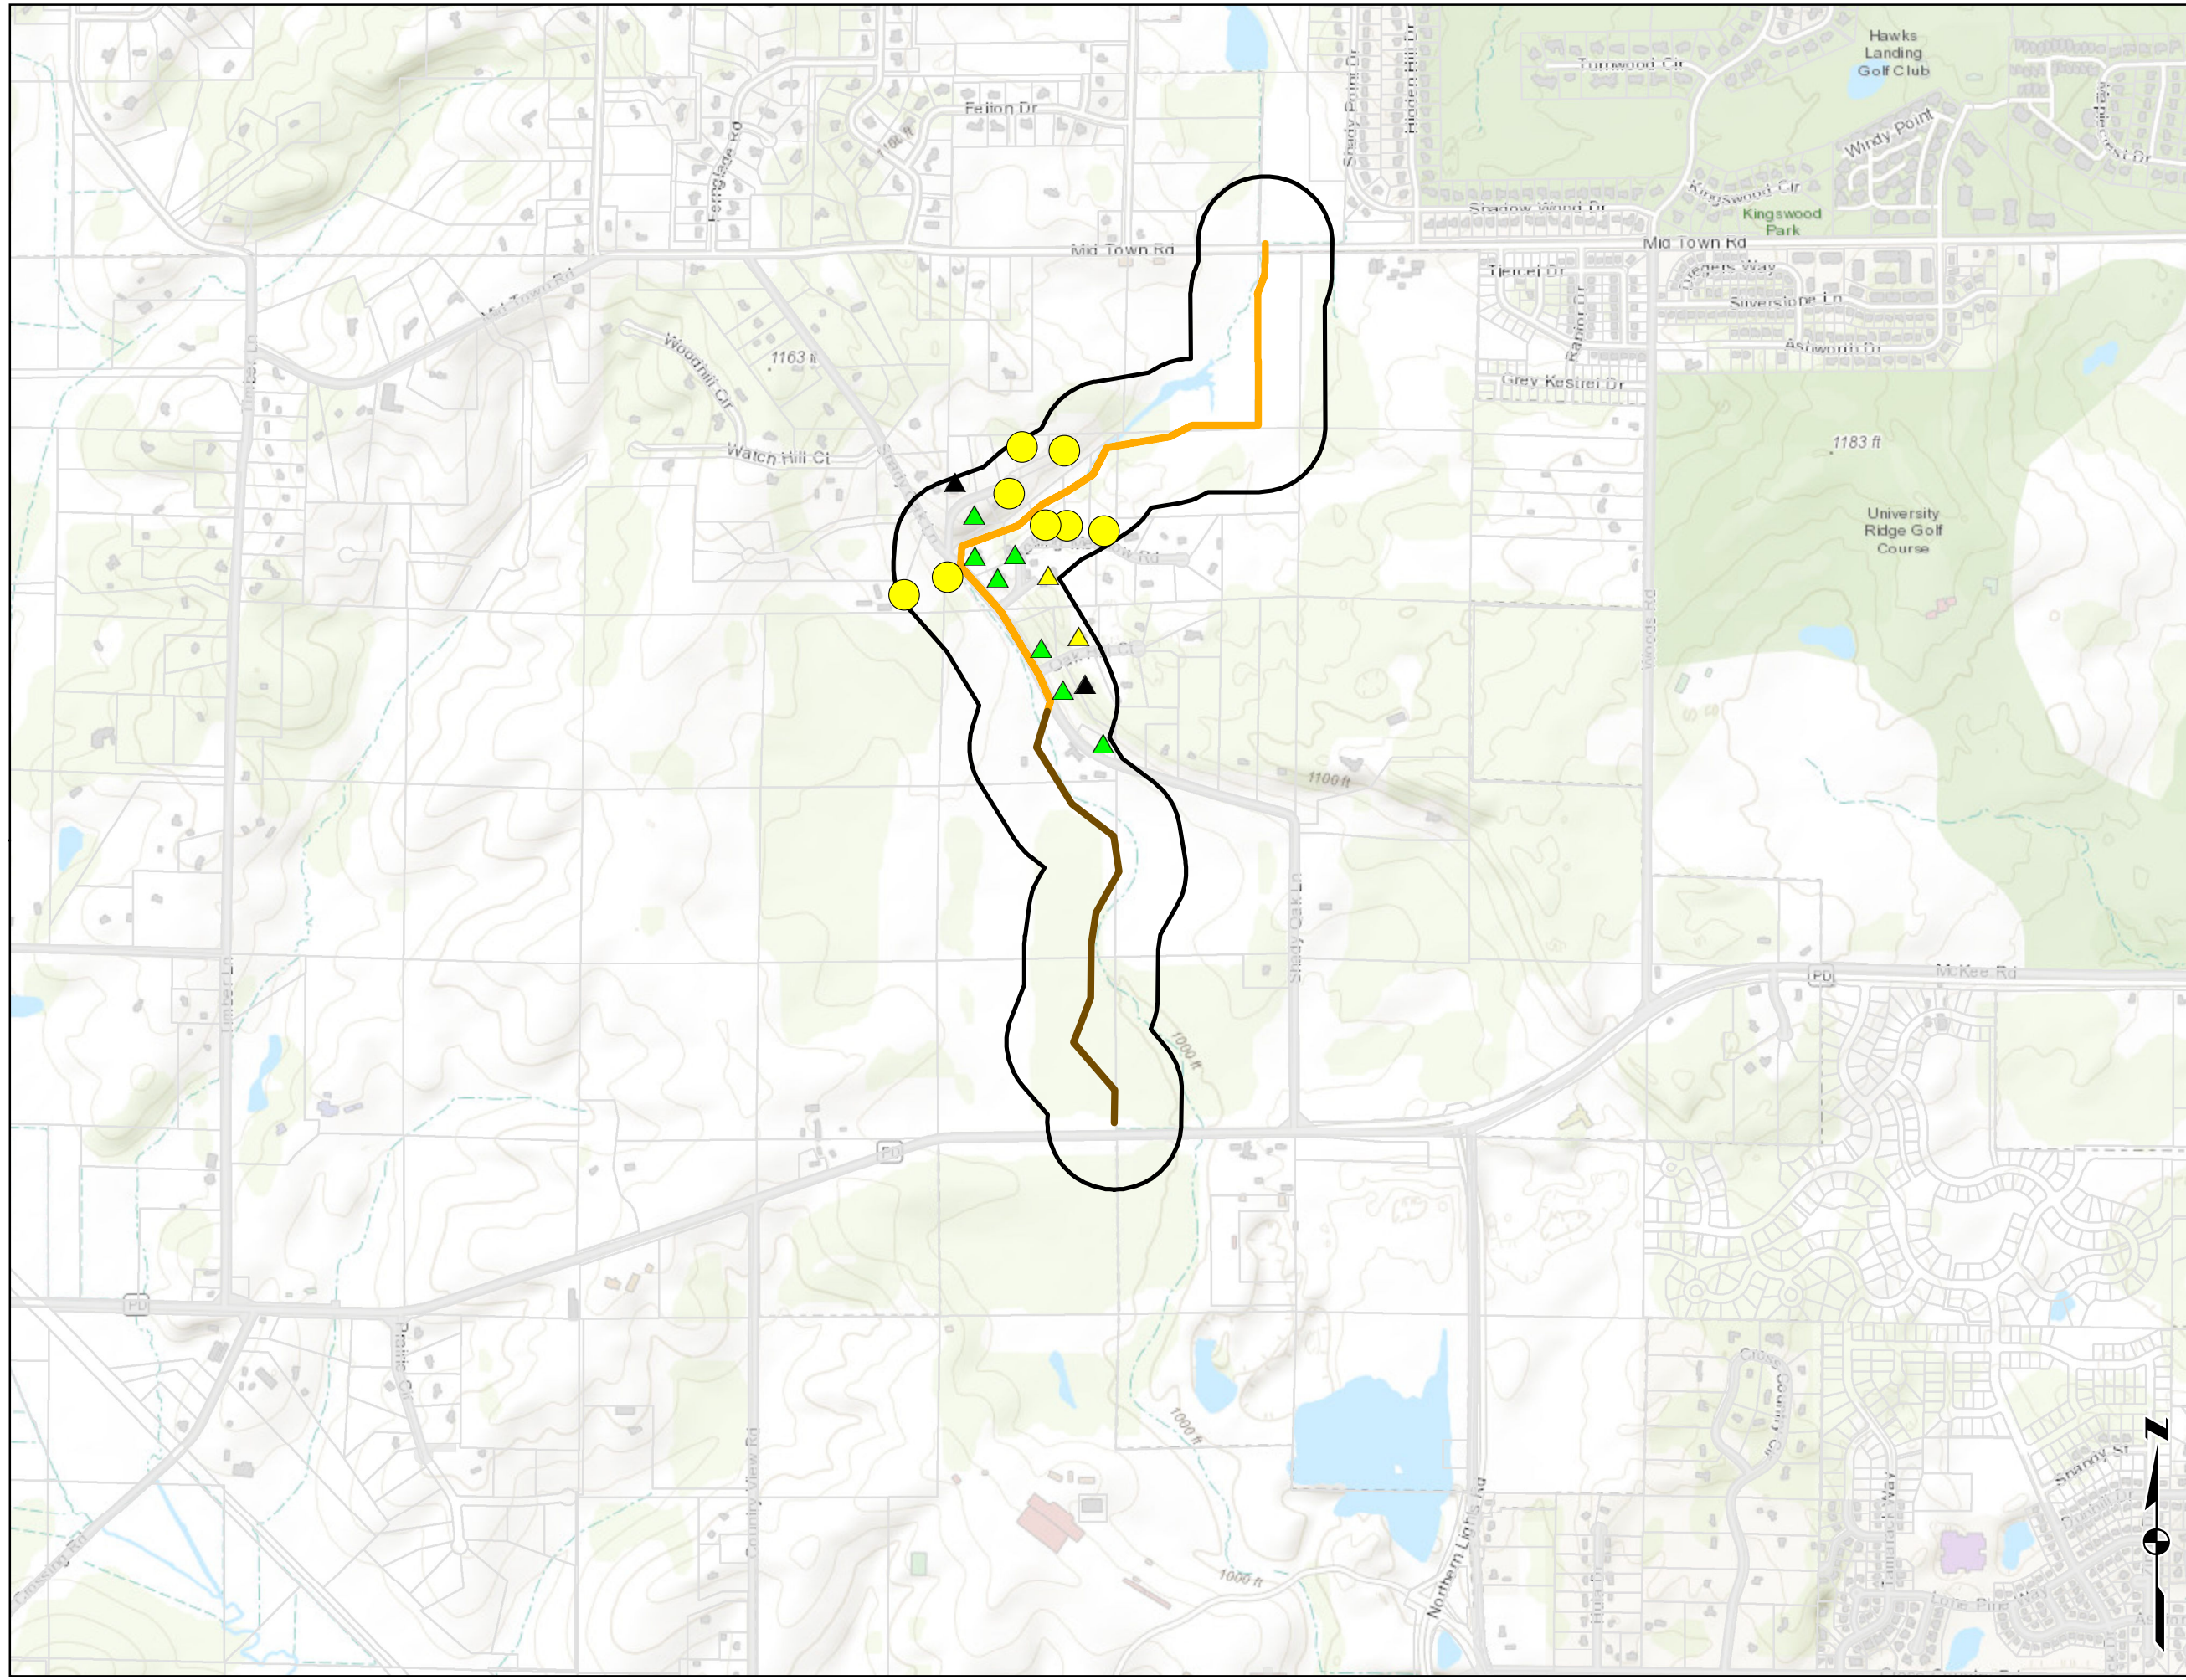
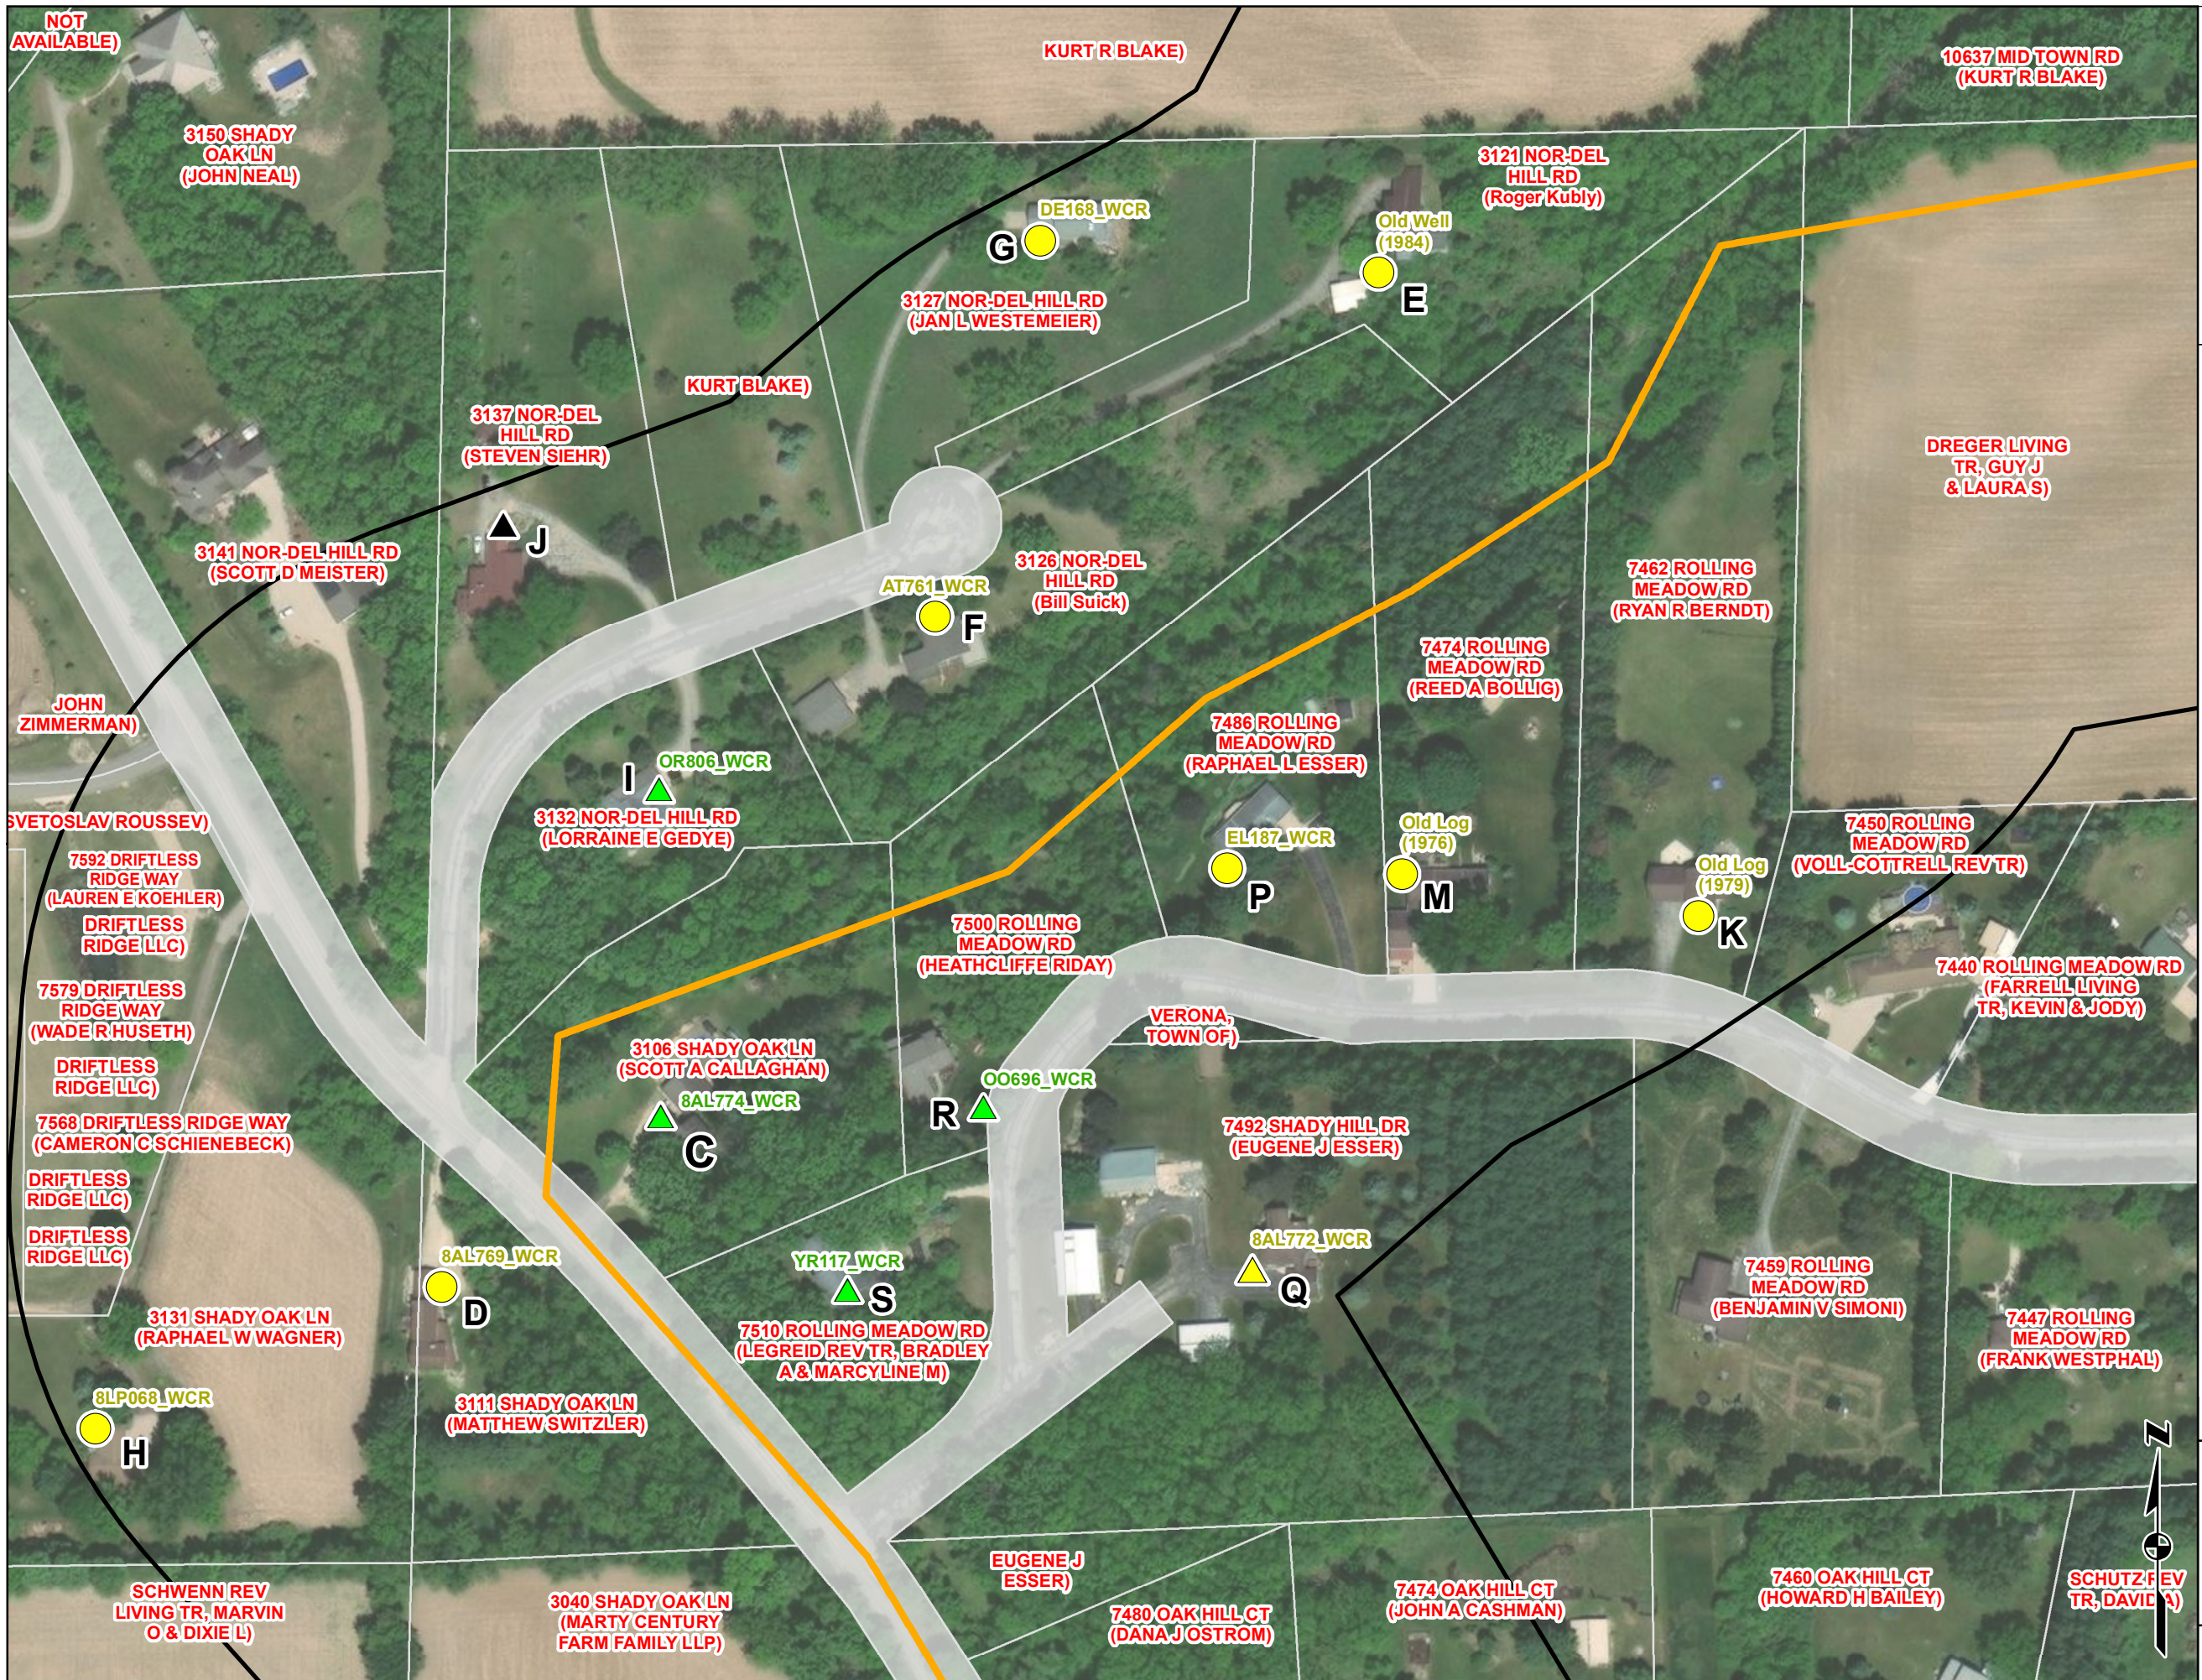
**FIGURE 1
PRIVATE WELLS
LOCATED WITHIN
PROJECT CORRIDOR**

Figure 1 shows the location of the shallow karst formation wells and the deep sandstone wells identified within the project corridor. **Figures 2A** and **2B** are detailed location maps that include the property owner names and well record identification. **Table 1** lists the private wells that were identified in the project corridor and summarizes their construction information.

Figure 1 – Private Wells Located within Project Corridor
